Opensystem West GmbH

Test Equipment for Diesel Fuel System

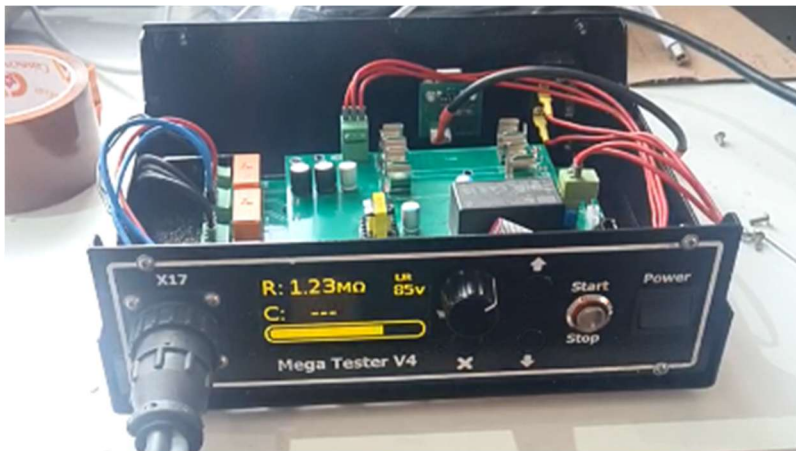
RC Measurement – Excessively high resistance, no valid capacitance value.

If your V4 device shows the above behavior, please try to perform a firmware update first. If this is not possible and the V4 cannot be detected or connected in the firmware update software, the microprocessor is most likely damaged. In this case, the device must be repaired at the factory.

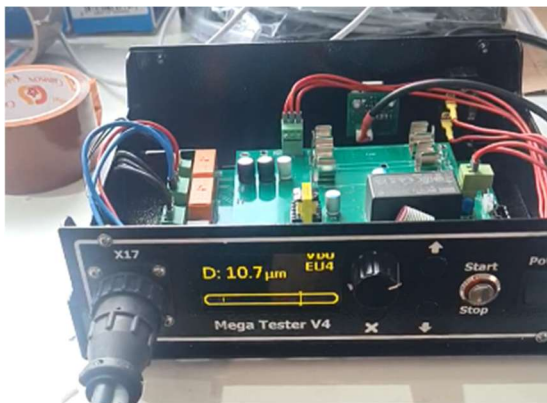
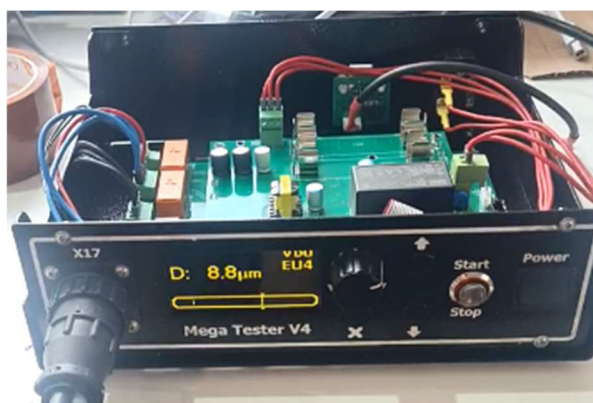
Gap unstable (floating condition)

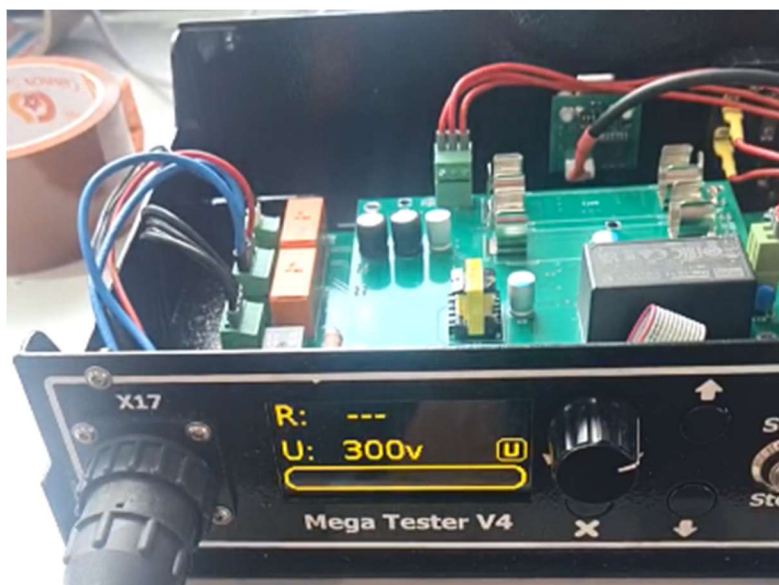
During the insulation resistance measurement, the “U” symbol is flashing.
